FUSION COATING REPAIR PROCEDURE

JOTUN JOTAMASTIC 90 PART A & B – HIGH BUILD EPOXY COATING Suitable for repairing fusion coatings to ductile iron products

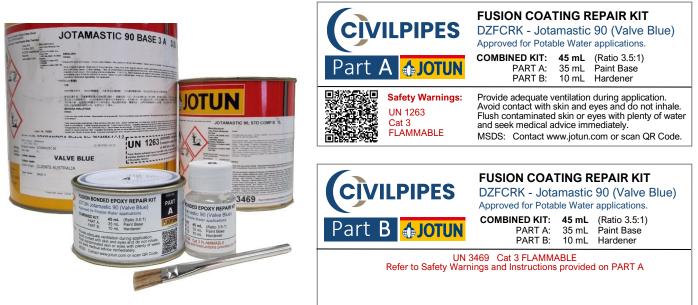
FUSION CO	DATING REPAIR KITS	5		
	Product Code	Description				ge
	DZFCRK	Jotamastic 90 Fusion Coating Repair Kit 45mL		0.15 m ² coverage at 300um WFT		
	DZFCRK4.5L	Jotamastic 90 Fusion Coating Repair Kit 4.5 L		15.2 m ² coverage at 300um WFT		
CIVILPIPE	S PTY LTD		E
